Inspection Report

Property Address:
123 Street Drive
Houston TX 77015

PROPERTY INSPECTION REPORT

By: Jerald Dee Jones TREC Professional Inspector #20960 / Armadillo Home Inspections of Houston, PLLC 3/23/2014

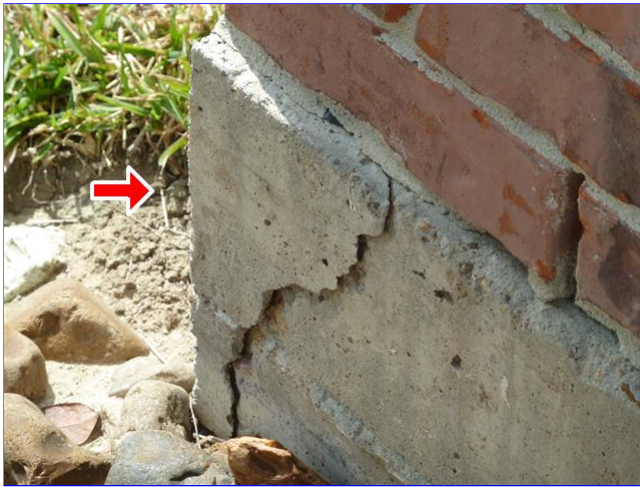
Concrete slab corner edges are prone to "pop" off during the removal of the forms. This is of no structural consequence unless the reinforcing is exposed or lacks adequate concrete cover. Proper repairs should be completed by a qualified contractor.

A. Item 1(Picture) Corner pop, one of three.

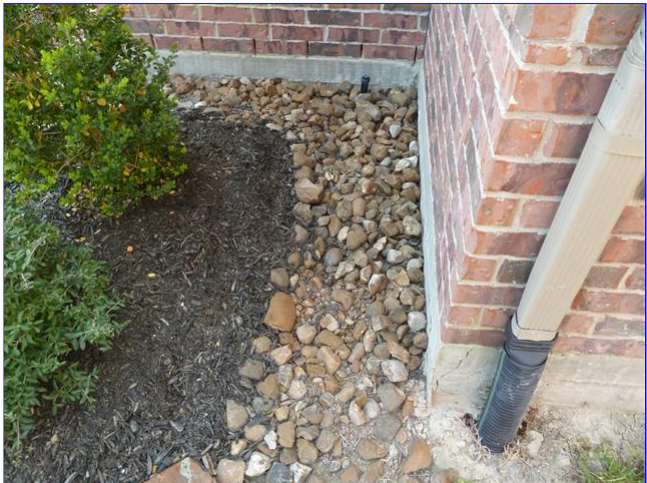
Adequate slope and grade around the home will remove any water away from the foundation and protect against settlement. The gutters are properly installed and the water is diverted to the street by underground piping.

B. Item 1(Picture) Adequate slope, grade, and gutters.

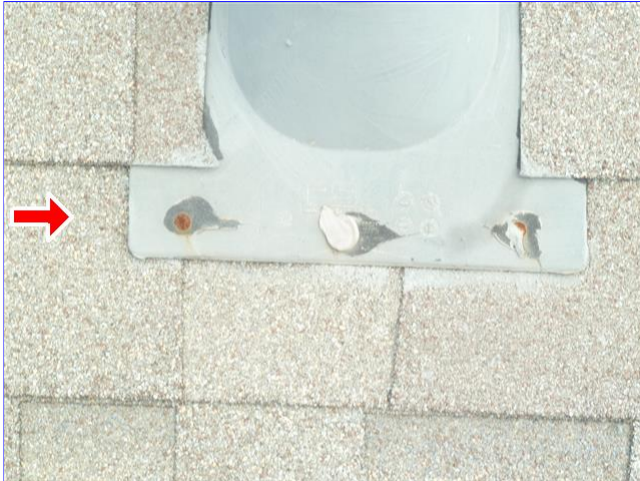
The architectural style roofing materials appear to be in good condition and functioning as intended. However one roof jack flashing was improperly installed with exposed nails and the caulking over the nail heads is failing. Install new caulking over the nail heads.

C. Item 1(Picture) Caulk over the exposed nail heads.

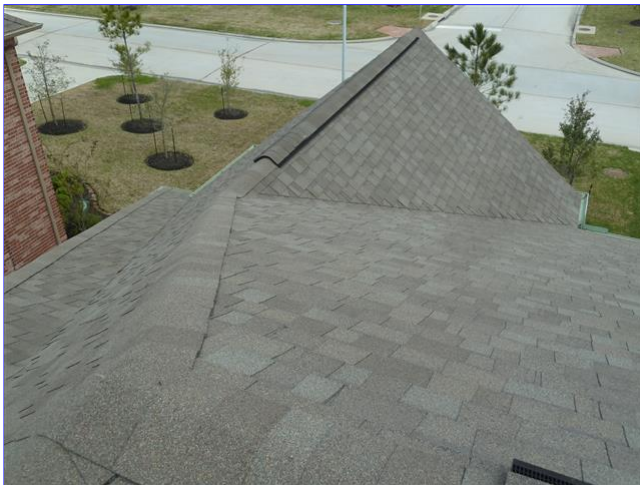
C. Item 2(Picture) Roofing materials and ridge vent.

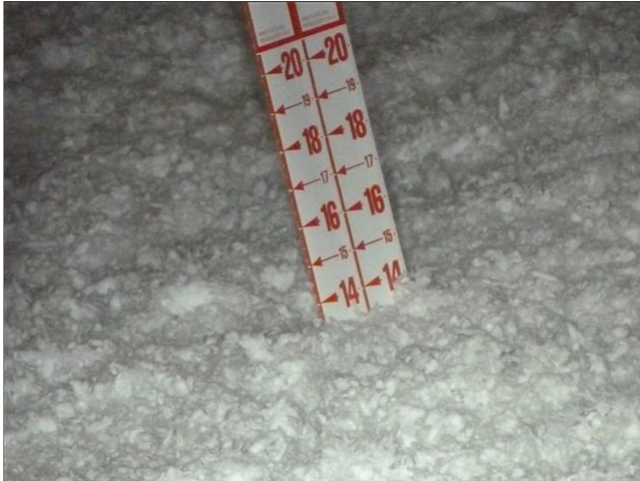
About 75% of the attic and attic floor was visible and/or accessible due to normal attic conditions (framing, ductwork, insulation, storage, inaccessible areas, etc.). There is the possibility that defects or other problems are present but not visible due to conditions. Note that attic insulation is never moved or otherwise disturbed, so anything under the insulation was not inspected or otherwise examined. Condition of attic and interior ceilings and walls seemed to indicate that there were no major defects relating to the the attic or roof at the time of the inspection. The insulation seemed well distributed and the ventilation from the ridge, soffit, and passive vents appeared adequate.

D. Item 1(Picture) Blown in attic insulation.

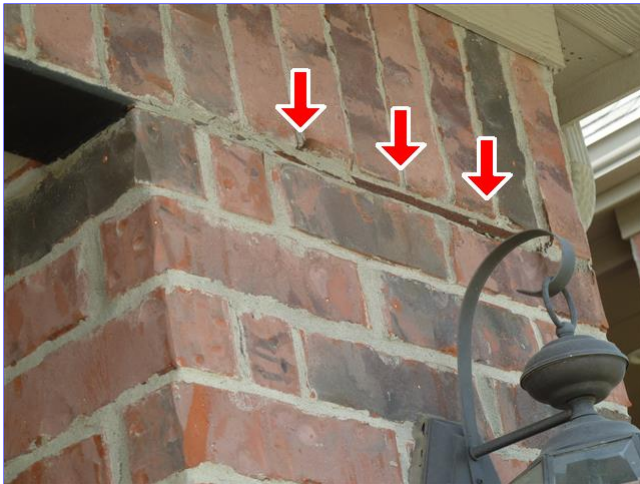
The interior walls showed no signs of damage of any type. The exterior walls seemed to be functioning as intended except for one area. The steel angle lintel above the garage opening was installed too close to the face of the brick veneer on the right side of the opening and has popped off the covering mortar joint. the exposed steel should be ground back, painted, and the mortar joint repointed.

E. Item 1(Picture) Exposed lintel.

The interior walls showed no signs of damage of any type. The exterior walls seemed to be functioning as intended except for one area. The steel angle lintel above the garage opening was installed too close to the face of the brick veneer on the right side of the opening and has popped off the covering mortar joint. The exposed steel should be ground back, painted, and the mortar joint repointed.

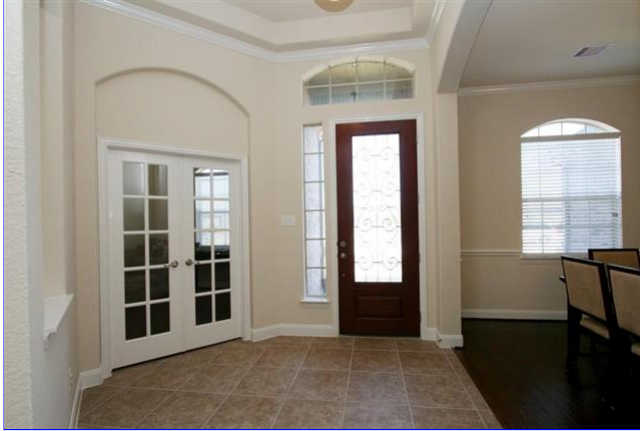
The ceilings and floors appear intact and are functioning as intended.

F. Item 1(Picture) Floors and ceilings, no damages found.

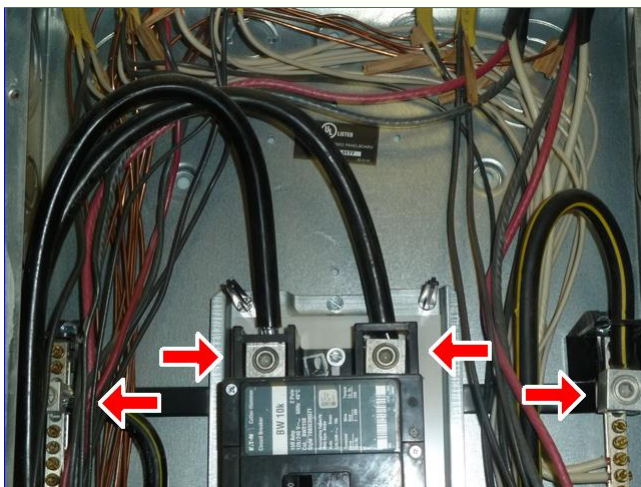
There is not any No-ox antioxidant grease present at the conductor connections in the main or sub panel boxes. Have a licensed and qualified electrical contractor make repairs.

A. Item 1(Picture) No No-ox

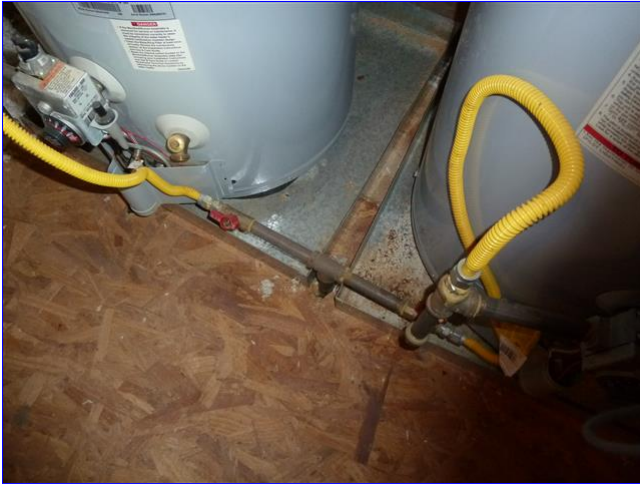
Neither the water heaters or the attic heating/cooling system are bonded to the natural gas lines running to these units. Electrical bonding is required for safety. It is impossible to tell during a visual inspection if all electrical bonding connections have been made.

B. Item 1(Picture) No bonding between gas lines and water heaters.

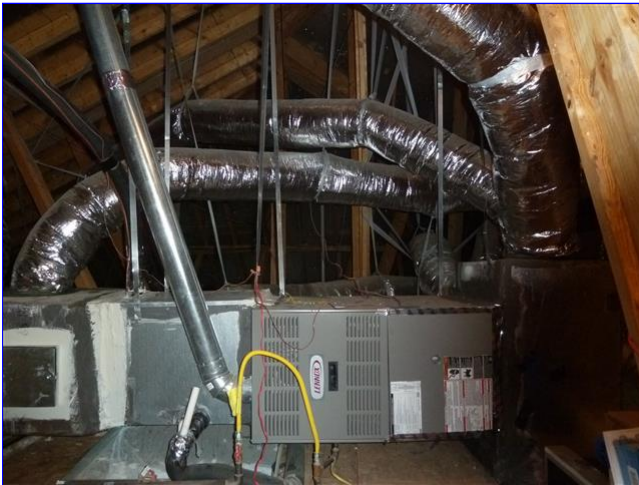
The heating system was not inspected for function because the ambient temperature was above 75 F. A visual inspection of the system was completed with no deficiencies found.

A. Item 1(Picture) Air handler/gas furnace

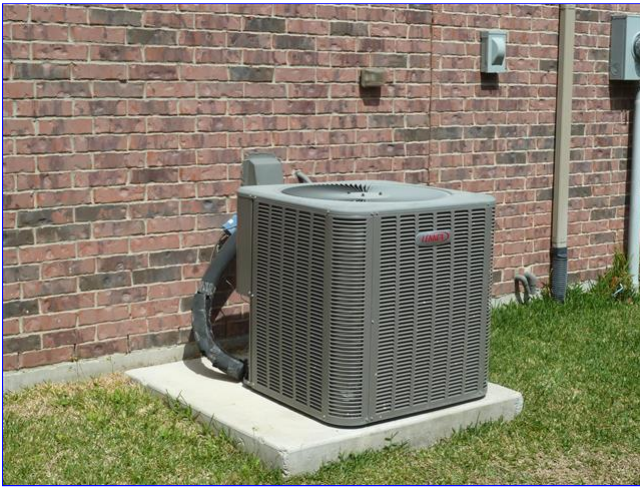
The AC condensing unit appeared to be in good condition, elevated above grade on a concrete pad, with the electrical cut off within sight of the unit.

B. Item 1(Picture) Condensing unit

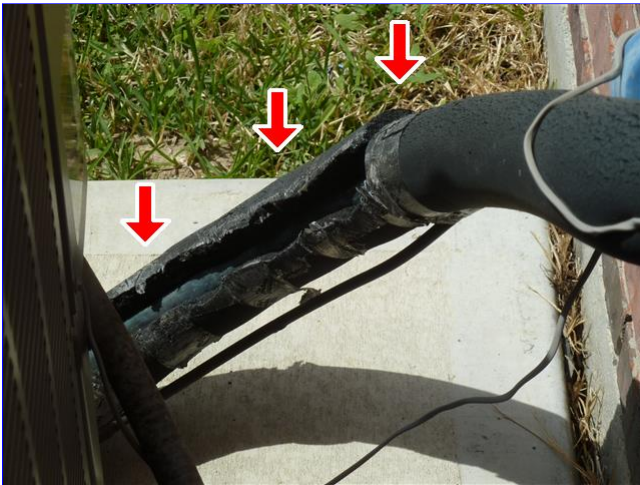
B. Item 2(Picture) Repair insulation

Repair the insulation on the suction line adjacent to the condenser.

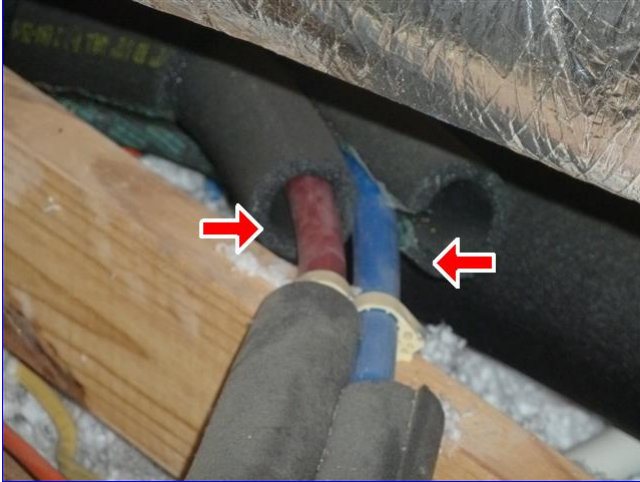
Water supply piping in the attic should be insulated so as not to freeze in winter and to prevent condensation on the hot water pipes from dripping to the attic floor (interior ceiling) during cool nights, causing moisture damage. Repair the area of missing insulation as shown in the photo.

A. Item 1(Picture) Missing insulation

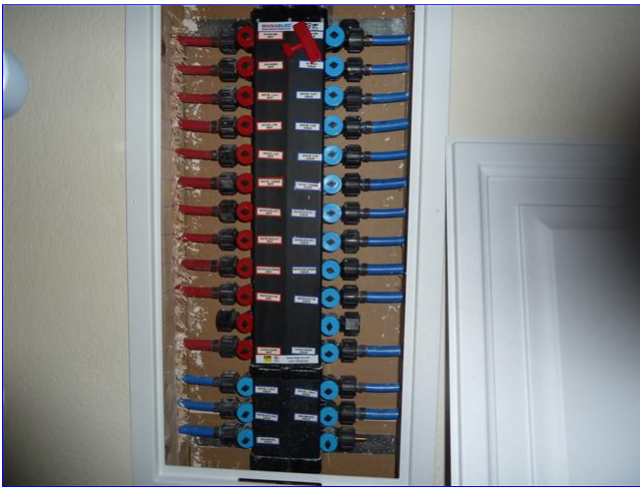
Note the PEX water control system located in the wash room. Water flow to all areas of the home can be controlled from here.

A. Item 2(Picture) PEX water system
